# MY SLOT NOTES

## IGT Ballast

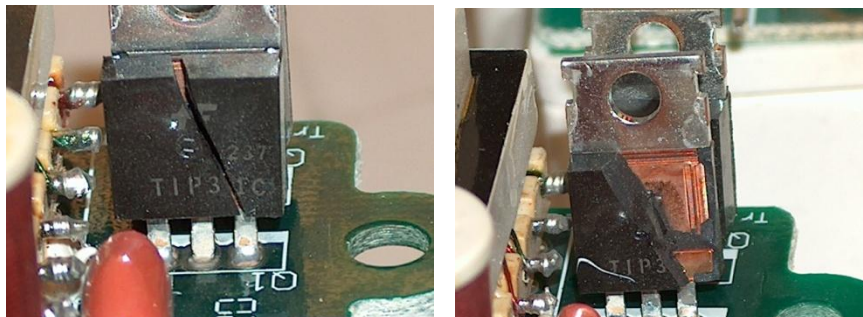
Q1 Tip31C Replaced with NTE291

Q2 Tip31C Replaced with NTE291

Q1 & Q2 TIP31C

**Cross Ref NTE291 (NPN) & NTE292 (PNP)  
Silicon Complementary Transistors Medium Power Amp, Switch**

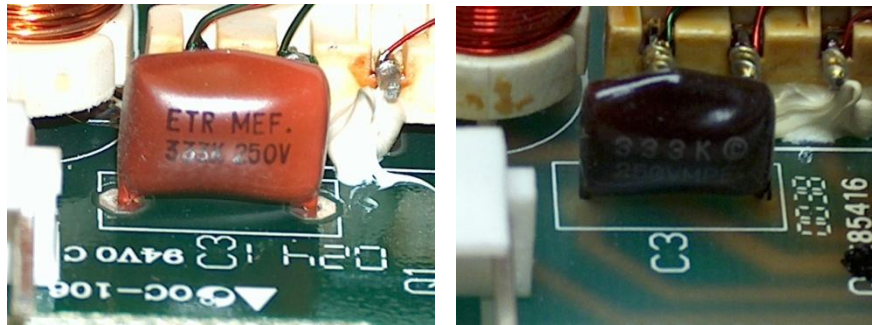
Also C3 will be bad - 333k 250v replaced with 333k 400v

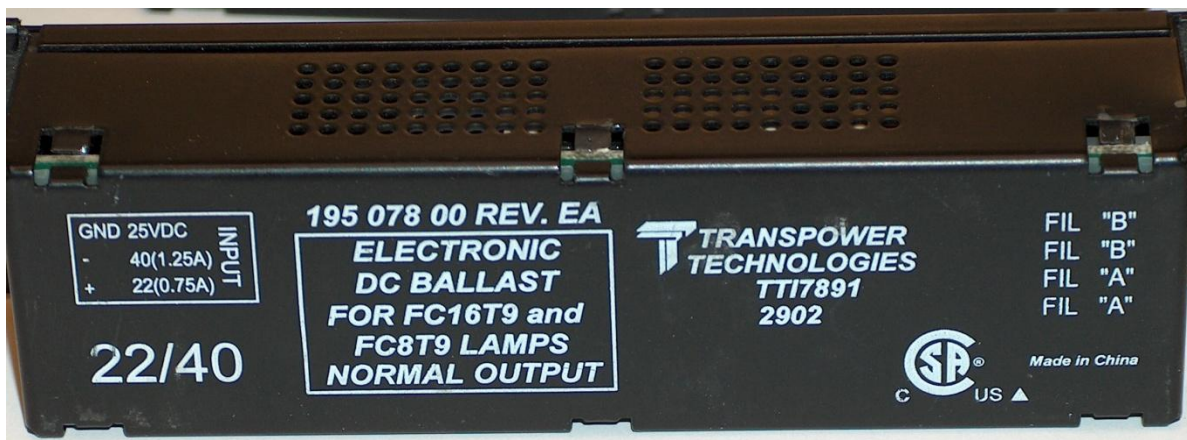
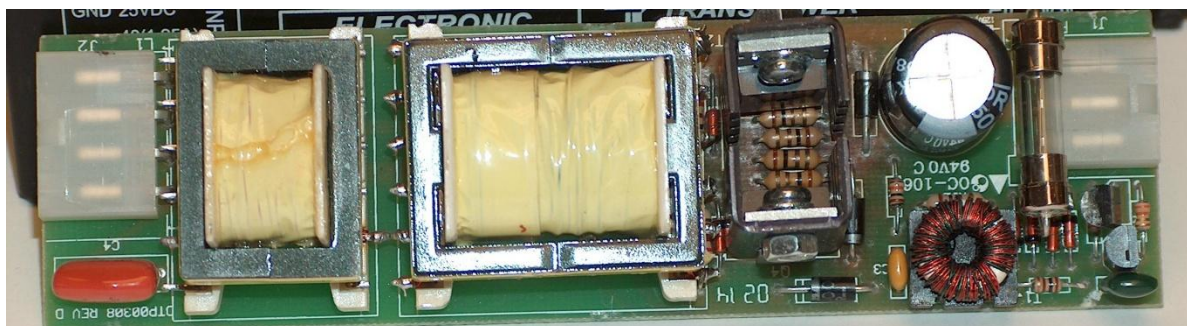
Sometimes you will also find C4 bad 103k 400v replaced with 103k 400v
