# MY SLOT NOTES

## *APS Model MCP8011*

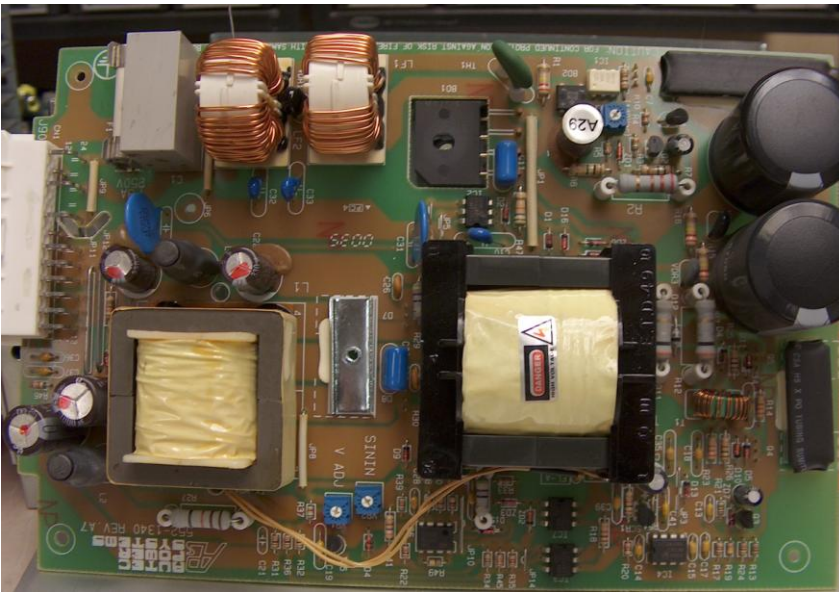
No 13 Volts

No 25 Volts

Main connector – cold solder joint

Found 4 with the same problem
