MY SLOT NOTES

APS

Model MCP8011

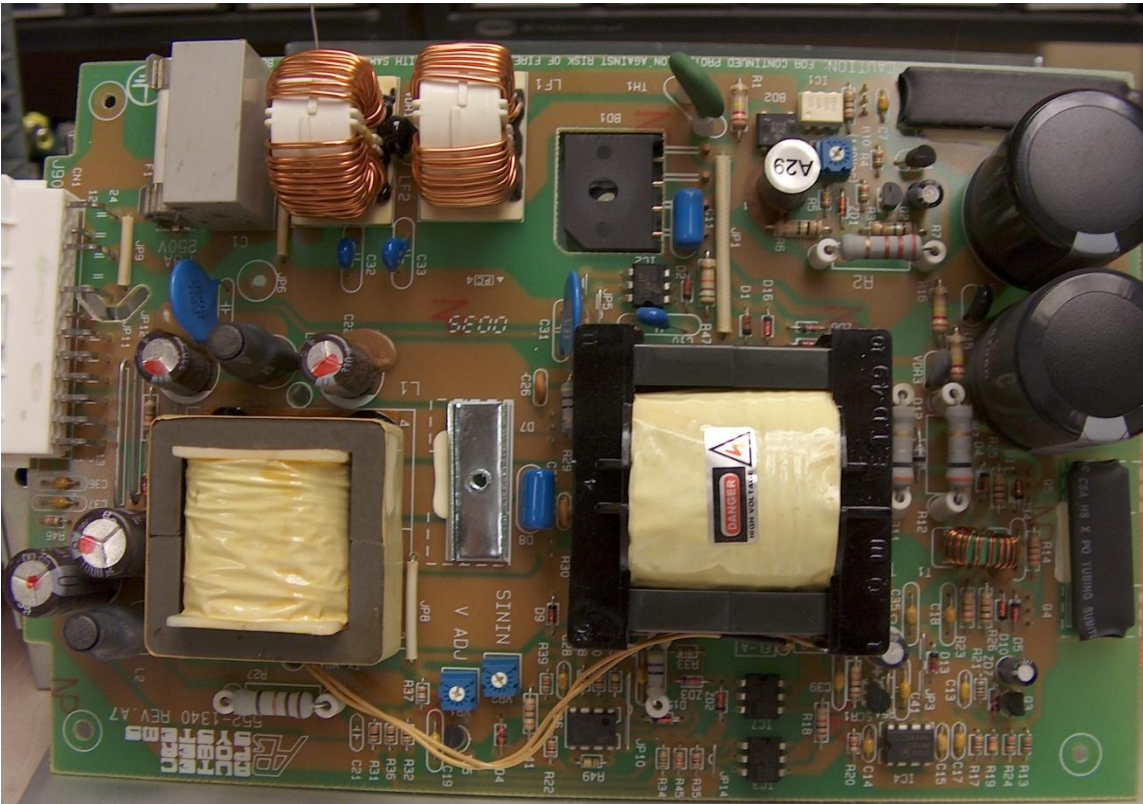
No 13 Volts

No 25 Volts

Main connector – cold solder joint

Found 4 with the same problem
